STATE OF WASHINGTON  
 DEPARTMENT OF HEALTH  
 SOUTHWEST DRINKING WATER REGIONAL OPERATIONS  
 P.O. Box 47823 Olympia, Washington 98504-7823  
 TDD Relay 1-800-833-6388

April 12, 2016  Dell Hilger 1121 Westside Highway Kelso, Washington 98626	<b>Beacon Hill Water and Sewer District          ID #15650D</b>	
	County:	Cowlitz
	System Type:	Group A Community
	Operating Permit Color:	Green
	Surveyor:	Teresa Walker
	Inspection Date:	March 30, 2016

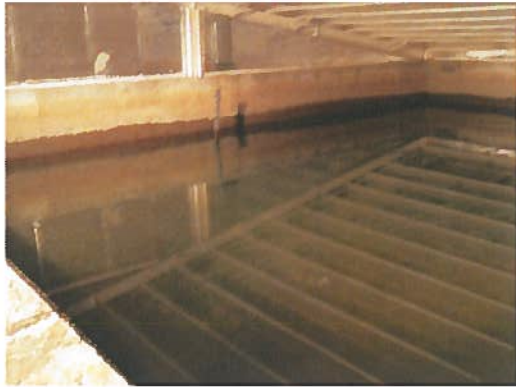
Woodbrook is a rectangular reservoir that is accessed from a ground level door. It has an aluminum roof in good condition. There is a concrete wall between two compartments.

**Woodbrook reservoir (roof reflection)**

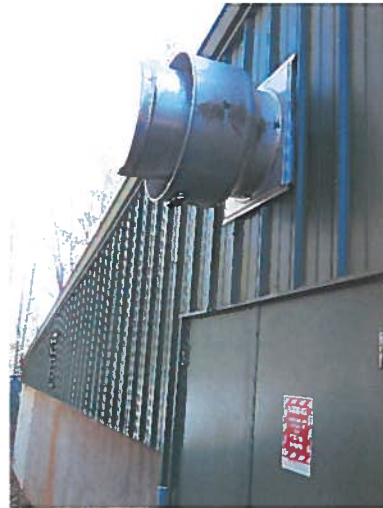
**Ventilation at Woodbrook reservoir**

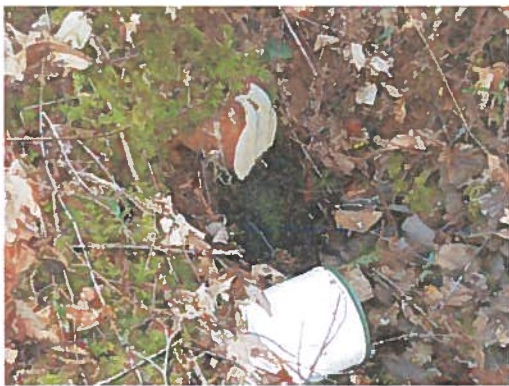
**Woodbrook Drain**

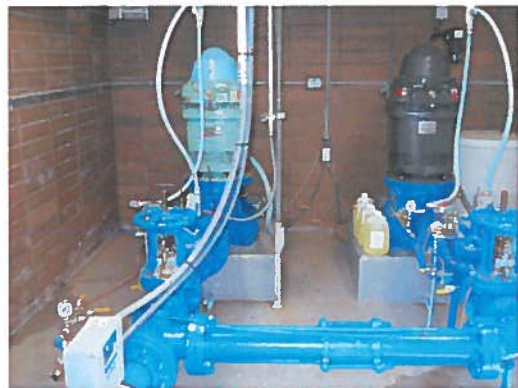
**Ostrander pump station**

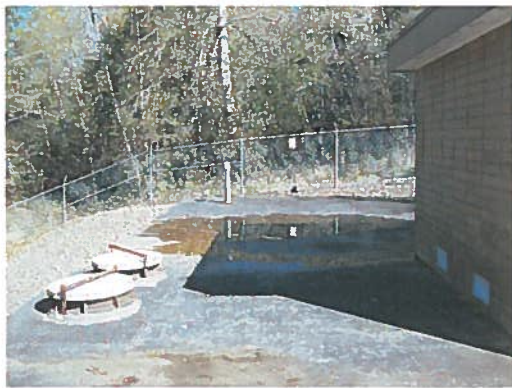
Ostrander does not have a gasketed hatch, as it is a manhole cover to an at-grade reservoir. **Please provide a watertight seal for this cover.** Ostrander and Skyline are below grade reservoirs and have at grade vents which are screened. Beacon Hill is an elevated steel tank supported by a steel truss. Beacon Hill will have a structural inspection performed next month. The vent for Beacon Hill does not have a screen. **Please modify the vent opening and install screens for Beacon Hill reservoir. Please confirm that the Beacon Hill tank support structure is structurally sound, following the inspection.**

**Ostrander reservoir hatches**

1. **Please provide a watertight seal for the Ostrander reservoir cover.**
2. **Please modify the vent opening and install screens for the Beacon Hill reservoir.**

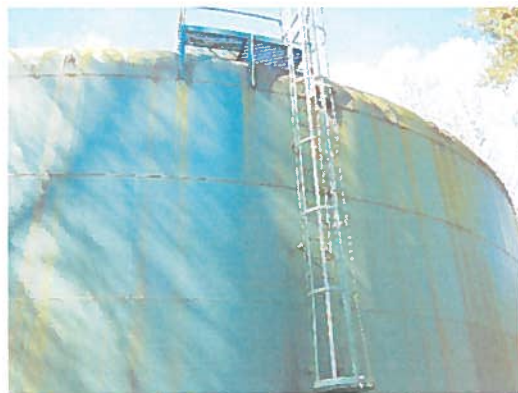
**Lexington Reservoir**

**The Lexington tank is in need of exterior pressure washing.**

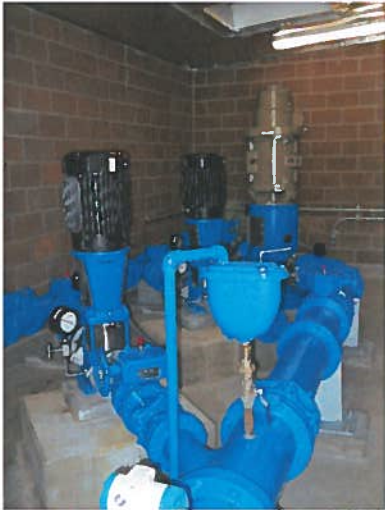
Grandview and Beacon Hill are very new pump stations in excellent condition. Skyline pump station has difficult access and one of the pumps is about 20 feet down in an underground vault.

**Beacon Hill PS**

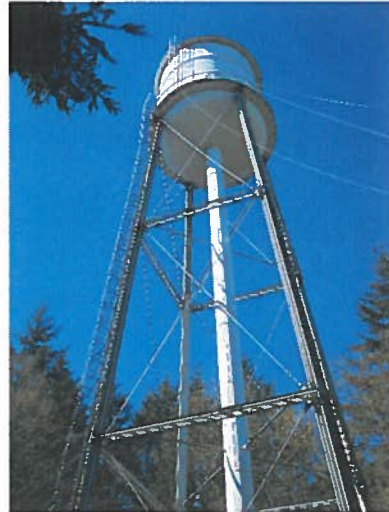
**Beacon Hill reservoir**

3. **Please confirm that the Beacon Hill tank support structure is structurally sound, following the inspection.**
4. **The Lexington tank is in need of exterior pressure washing.**
5. **This system should plan for installing small booster pump stations for areas where the pressure is below 30 psi.**
6. **The system should investigate adding mixing to the reservoirs to lower trihalomethane levels (THMs).**

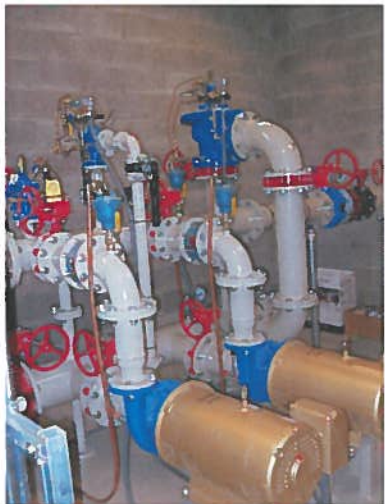
The Grandview pump station was finished in 2015. System hydraulics are unique for this pump station design and it must operate in conjunction with Skyline pump station as it has no reservoir for surging. Pressure reducing stations were added as water hammer was an initial problem. The pumps are VFDs, and operation is prone to problems according to the operator.

**Grandview PS**

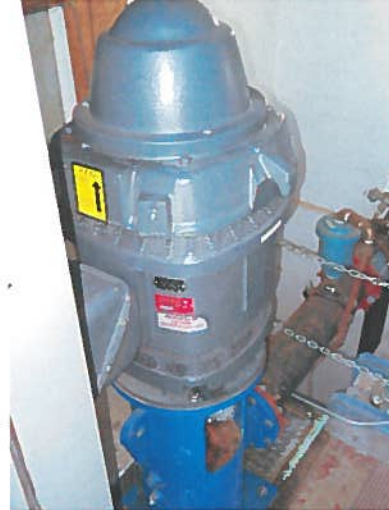
**Skyline PS**

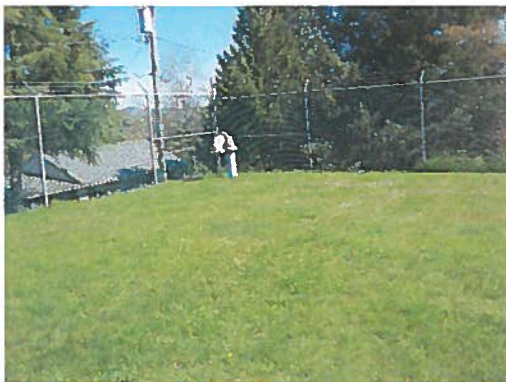
**Skyline reservoir vents**

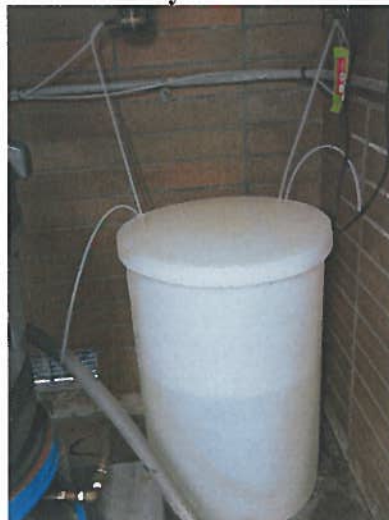
Hypochlorite is fed directly into the Ostrander reservoir, although CT is not required. An average residual of 0.5 to 0.8mg/l is maintained.

**Chlorination at Ostrander**
