STATE OF WASHINGTON
DEPARTMENT OF HEALTH
 SOUTHWEST DRINKING WATER REGIONAL OPERATIONS
 P.O. Box 47823 Olympia, Washington 98504-7823
 TDD Relay 1-800-833-6388

April 12, 2016 Dell Hilger 1121 Westside Highway Kelso, Washington 98626	Beacon Hill Water and Sewer District ID #15650D	
	County:	Cowlitz
	System Type:	Group A Community
	Operating Permit Color:	Green
	Surveyor:	Teresa Walker
	Inspection Date:	March 30, 2016

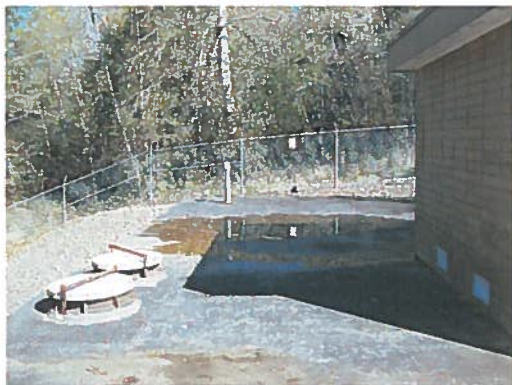
Ostrander reservoir hatches

Ostrander does not have a gasketed hatch, as it is a manhole cover to an at-grade reservoir. **Please provide a watertight seal for this cover.** Ostrander and Skyline are below grade reservoirs and have at grade vents which are screened. Beacon Hill is an elevated steel tank supported by a steel truss. Beacon Hill will have a structural inspection performed next month. The vent for Beacon Hill does not have a screen. **Please modify the vent opening and install screens for Beacon Hill reservoir. Please confirm that the Beacon Hill tank support structure is structurally sound, following the inspection.**

1. **Please provide a watertight seal for the Ostrander reservoir cover.**
2. **Please modify the vent opening and install screens for the Beacon Hill reservoir.**

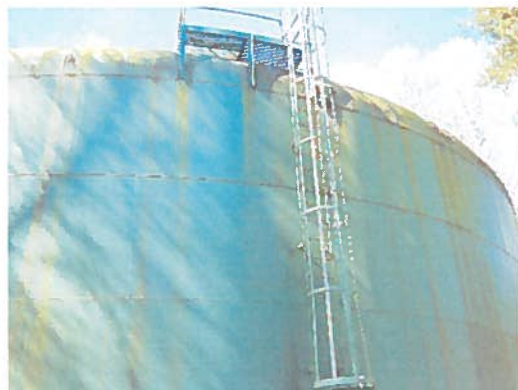
Lexington Reservoir

The Lexington tank is in need of exterior pressure washing.

3. **Please confirm that the Beacon Hill tank support structure is structurally sound, following the inspection.**
4. **The Lexington tank is in need of exterior pressure washing.**
5. **This system should plan for installing small booster pump stations for areas where the pressure is below 30 psi.**
6. **The system should investigate adding mixing to the reservoirs to lower trihalomethane levels (THMs).**

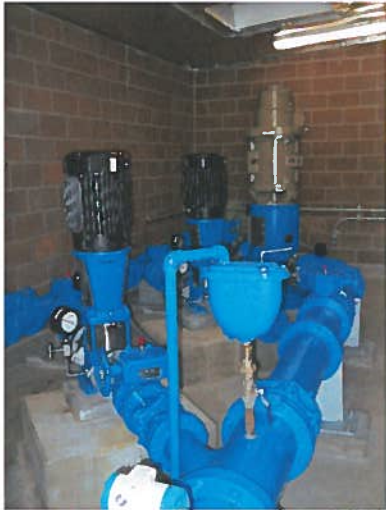
Beacon Hill PS

Grandview and Beacon Hill are very new pump stations in excellent condition. Skyline pump station has difficult access and one of the pumps is about 20 feet down in an underground vault.

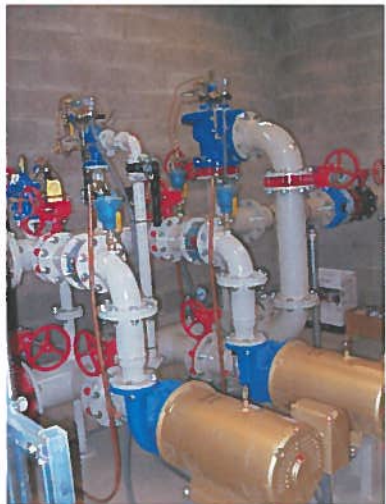
Grandview PS

The Grandview pump station was finished in 2015. System hydraulics are unique for this pump station design and it must operate in conjunction with Skyline pump station as it has no reservoir for surging. Pressure reducing stations were added as water hammer was an initial problem. The pumps are VFDs, and operation is prone to problems according to the operator.
